Ancona Report

WATER MONITORING REPORT 1997 - 2009

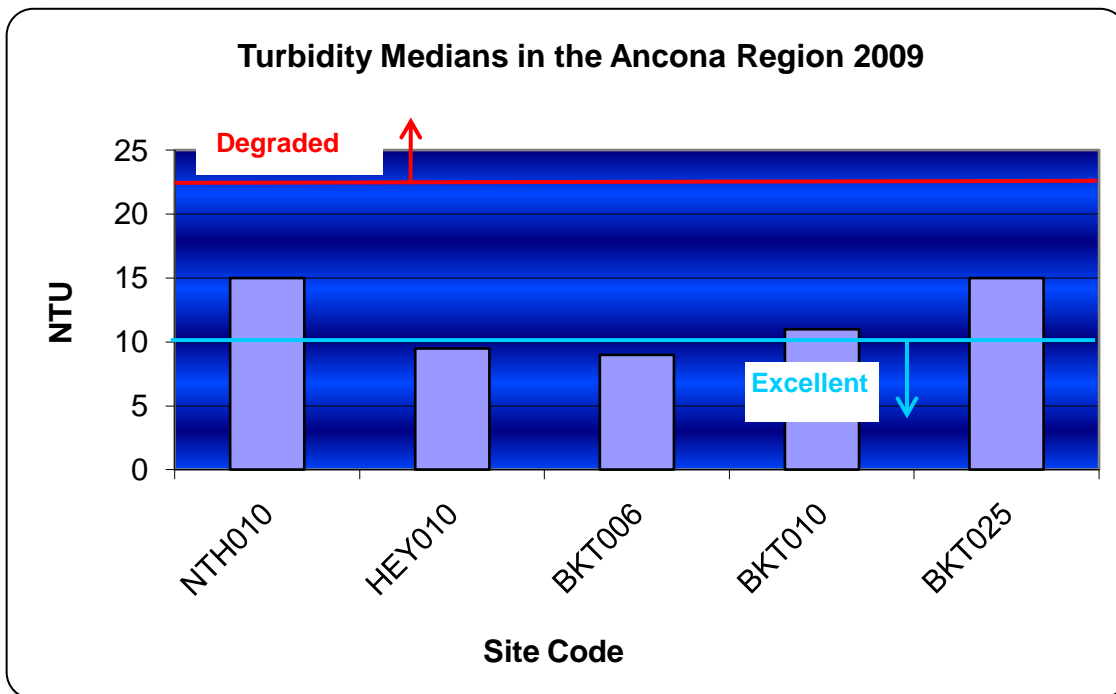
Note: Ratings shown on this graph are for the Valleys

Figure 4 above shows annual median results for the 2009 calendar year only.

- Upper Heyfield Creek continues to be a good example of the variation seen in turbidity, with results swinging from good to fair, through to excellent then degraded, and improving to excellent again in 2009. More frequent monitoring needs to occur to determine anything solid about this site or indeed this region.
- Brankeet Creek at Ancona (BKT006) has returned to historic levels for turbidity in 2009. Results were high in 2008, however it must be noted that less than five results were used to calculate the median in 2008, so it may not be as representative of the usual conditions in 2008 as it would have been if there had been more than five results used.
- Brankeet Creek at Mitchell Road (BKT010) and Brankeet Creek at Ancona Woodfield Road (BKT025) are rated as "Good" and "Poor" respectively in 2009, consistent with 2008 results.

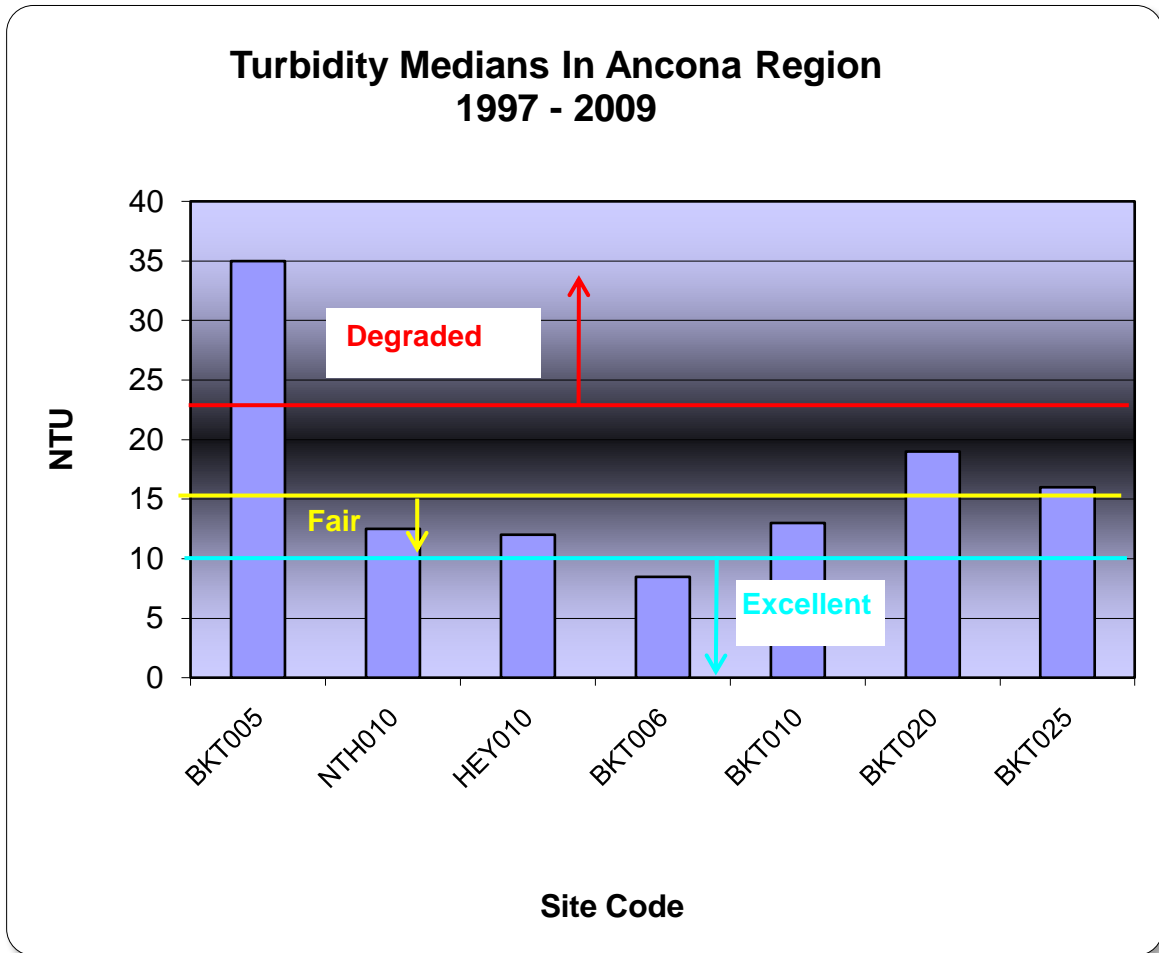
Figure 5 below shows the overall LONG TERM medians for the sites in the Ancona Region over the 13 years of monitoring.

Note: Ratings shown on this graph are for the Valleys

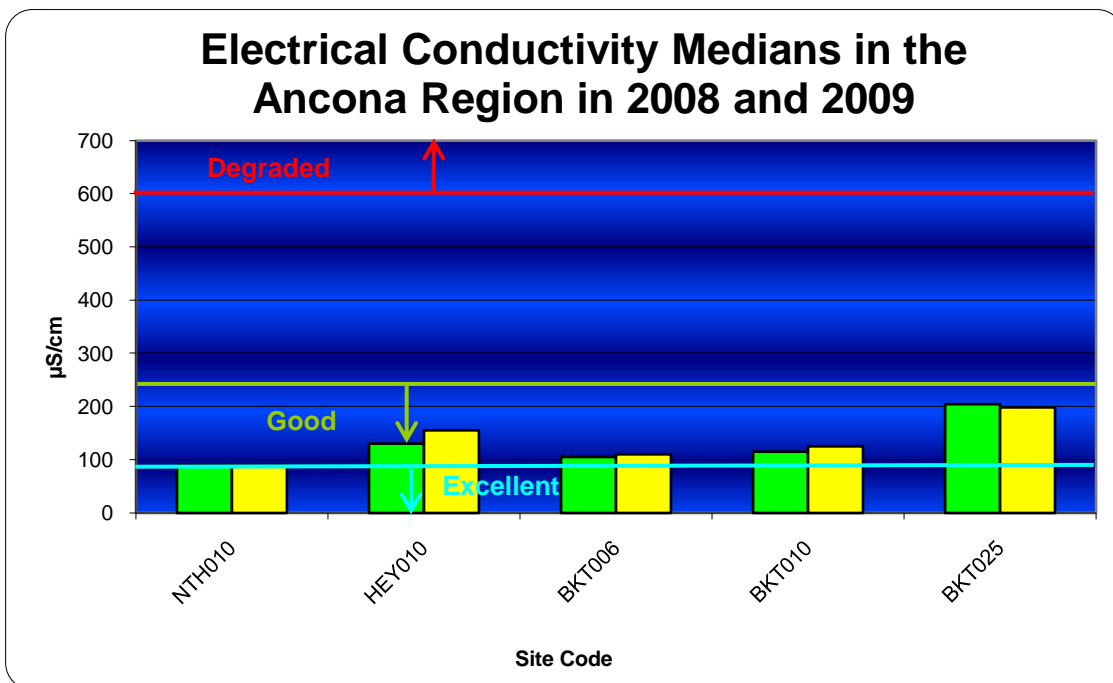
Note: Ratings shown on this graph are for the Valleys

Figure 6 above shows annual median electrical conductivity results for the 2008 and 2009 calendar years.

- Electrical conductivity (Salinity) has consistently rated as "GOOD" at all sites in the Ancona Landcare Group Region during the periods that they have been monitored.

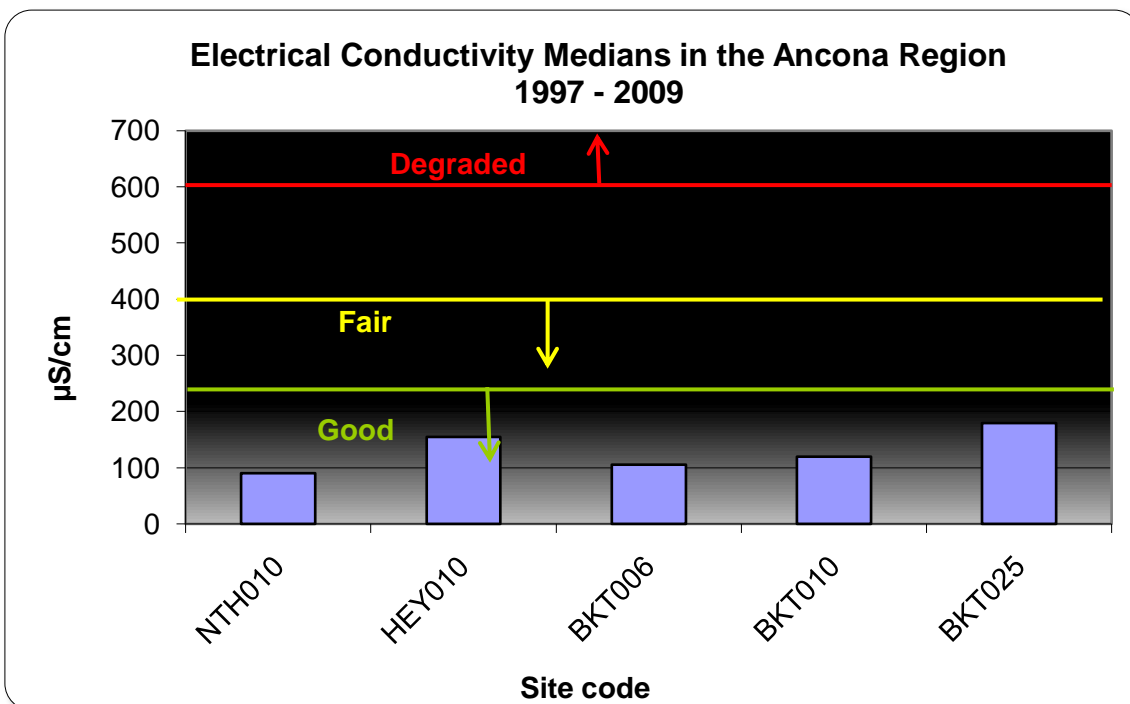
Note: Ratings shown on this graph are for the Valleys

Figure 7 above shows the overall LONG TERM median Electrical Conductivity for the sites in the Ancona Region over the 13 years of monitoring.
